RESEARCH CONSTRUCTION REPORT

Thin-Whitetopping Overlay Composite

Location: Kalispell, Montana

Project No.: STPP 1-2 (93) 121 East Idaho St.

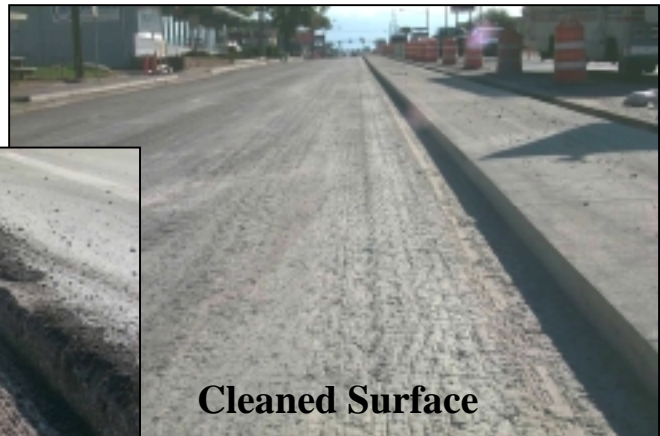
These images show the milled asphalt Before and after cleaning. Sweeper and vacuum trucks were used

Cleaned Surface

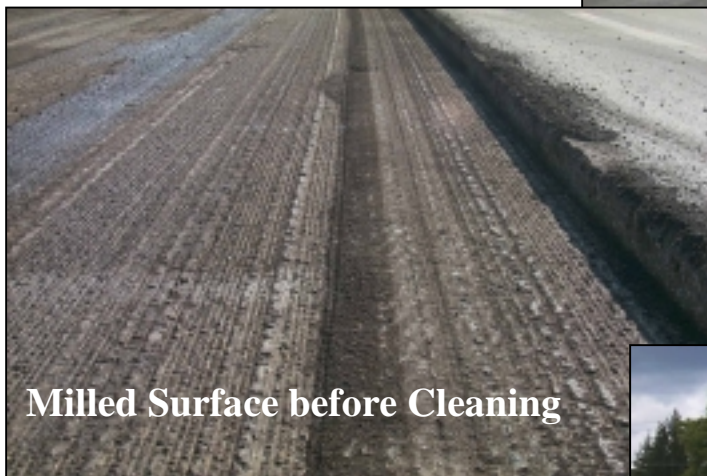
Milled Surface before Cleaning

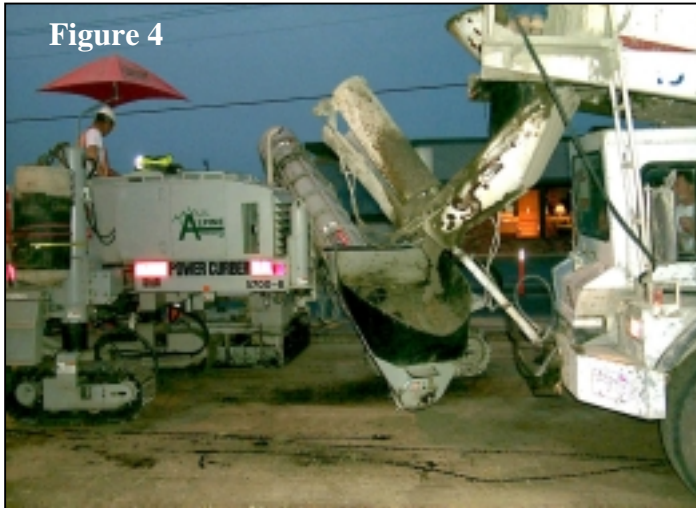
Figure 4

In order to keep grade and allow the Bidwell Deck Paver to be used, a five-foot slipform paver (Power Curber 5700-B, figure 4) placed the initial Whitetopping from the centerline. Placement started from the east end. The contractor allowed too much water to

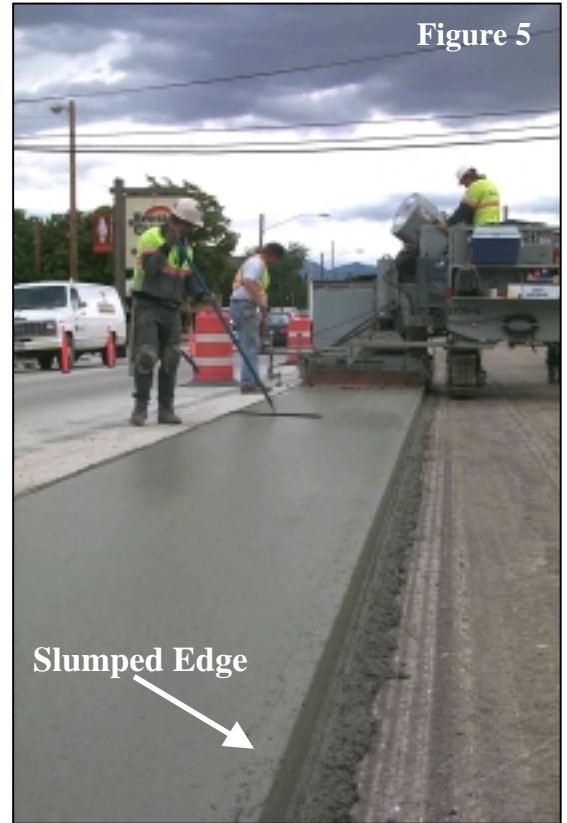
be added to the concrete in the mixing truck. In addition, water was being added to promote smoother flow down the chute. Apparently, the amount of fibers (3lb. Per cu/yd) in the mix was clumping in the chute and the driver felt it was necessary to add more water. This in turn increased the slump to a level in which while finishing the exposed (northern edge) of the placement it sloped downward, no longer a flat surface. Figure 5 shows the slumped edge and the spillage left behind from the paver. Since this edge would no longer match the edge when the deck paver would be used the contractor was asked to remove approximately 2/10 of a meter

Slumped Edge

from the edge of the sloped area. This was done by saw cutting down to the AC layer. Although this was an unfortunate event to the contractor, it

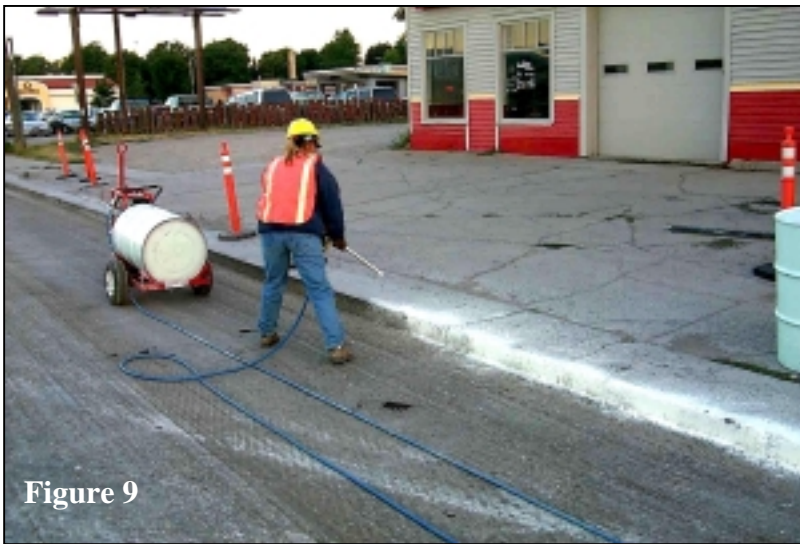
Figure 9

to the use of the Bidwell Paver, curing compound was also applied as a bond breaker to the curbing as seen in figure 9. Mixing of the 55-gallon drum was done by rolling it up

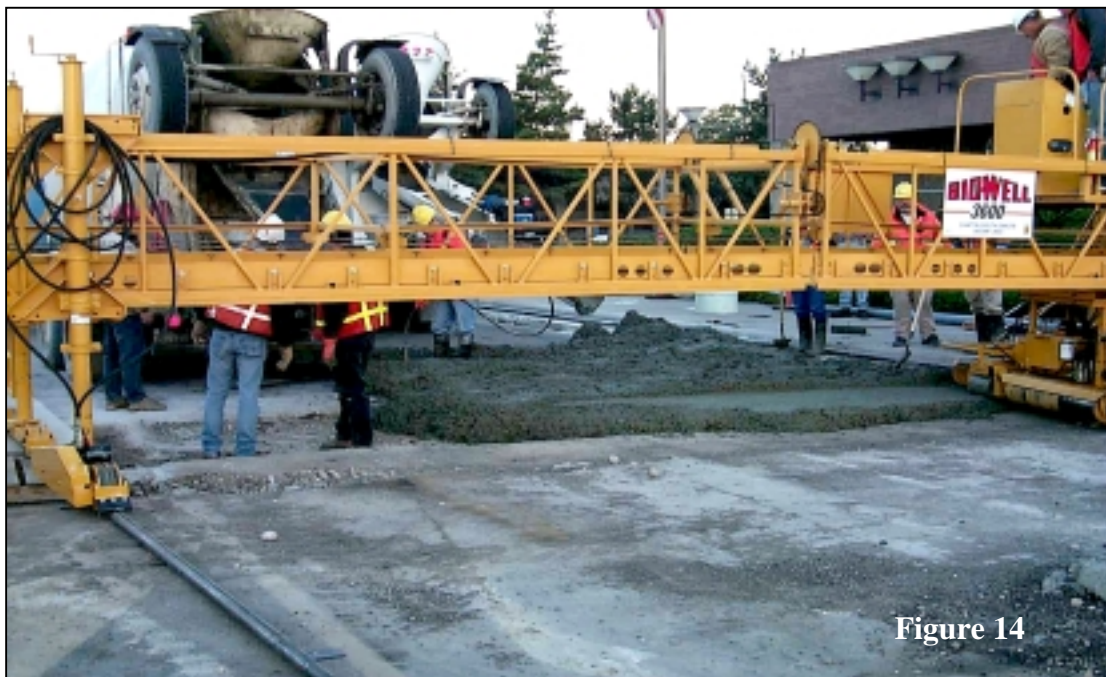
the effectiveness of the design change. Figure 14 is the beginning of the project using the Bidwell 3600 Deck Paver. The rails for the paver were supported by the existing curb and the slip-formed five-foot whitetopping pavement previously placed.

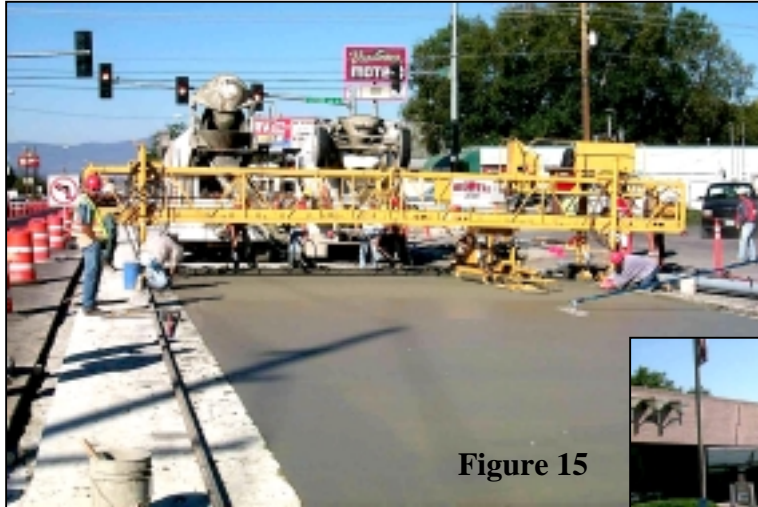
Figure 15

Once the Bidwell was in place and operating, placement of the PCCP went smoothly. The contractor coordinated two front dispensing concrete trucks to be in front of the Bidwell constantly (figure 15). The finishing crew was diligent in finishing and brooming. Curing compound

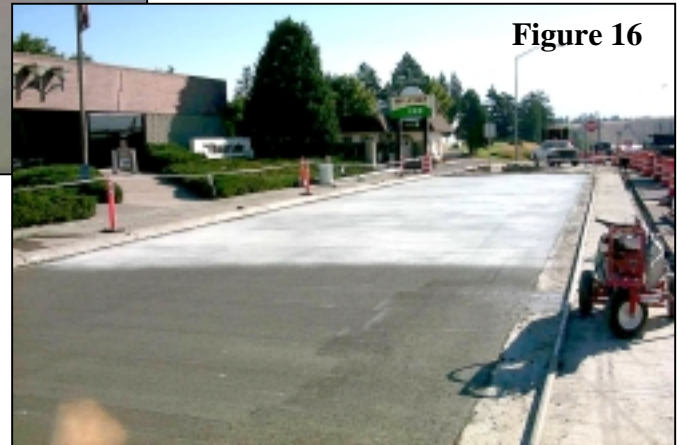
Figure 16

was applied soon after the brooming (figure 16).

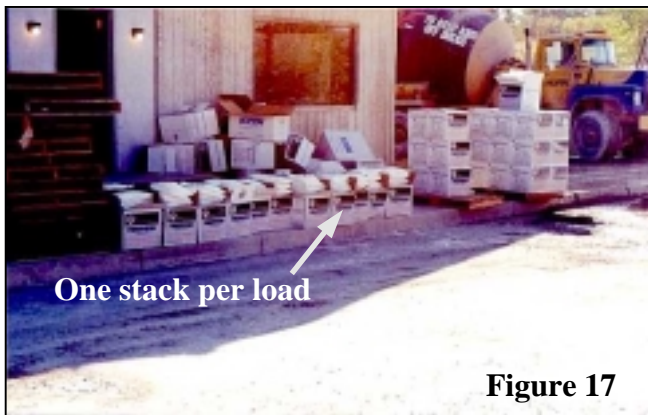
Figure 17

manually loaded into the trucks at the batch plants. The fibers were introduced first with water, agitated and then followed by the aggregates, cement and additives. The batcher stacked the appropriate amount of fibers per load for the drivers (figure 17). At this time, fiber reinforcing is a standard practice for thin whitetopping applications. This practice will be closely monitored to see if the addition of fibers decreases cracking and/or spalling with the thin whitetopping.

One stack per load

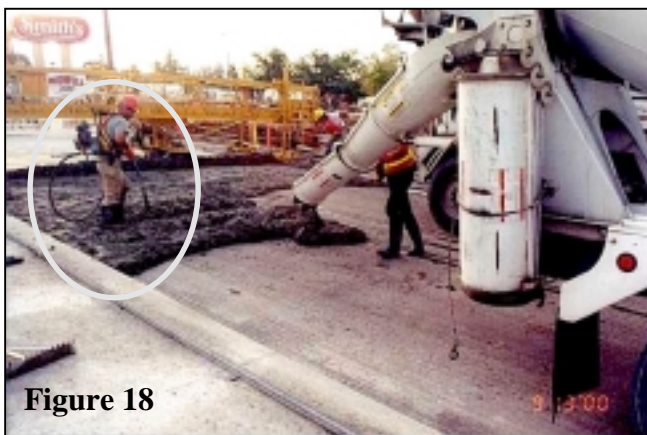
Figure 18

Another important factor in the placement of whitetopping is the vibration needed to properly consolidate the PCCP. The contractor used a motorized backpack foundation style vibrator or stinger for this project (figure 18). Only one vibrator was used. It was noted that the individual operating the vibrator initially was inserting the vibrating head too long into the concrete. To much vibration can unconsolidated the PCCP. The MDT inspector instructed the operator on the correct procedure. Only one vibrator was used during placement. Upon observing the amount of effort this individual needed to keep up with the

placement, there should have been two vibrators used in this project. This most likely was the reason on a small section of the placement that the PCCP was not vibrated sufficiently to remove the pockets left by the workman's boots. The yellow outline on figure 19 approximately shows the lack of consolidation. The circumstance that caused this to happen was quite clear. The workman operating the stinger took a very short break to quickly eat. While doing this, the paver continued to operate and proceeded to move over the spot that had not been vibrated. This unconsolidated section looked fine until the saw crew began cutting at this spot. At that time the weight and action of sawing breached the PCCP.
